What it takes to Clean India

Author - Rahul Banerjee, Published on - 1.11.2015

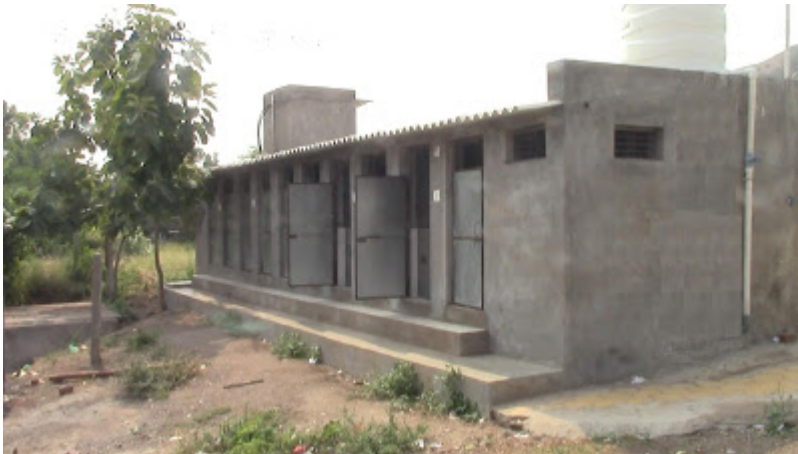
The enormity of this problem was brought home to us in the construction of fifteen pairs of toilets and bathrooms in the Rani Kajal Jeevan Shala in Kakrana in two blocks of ten and five units for boys and girls respectively as shown below.

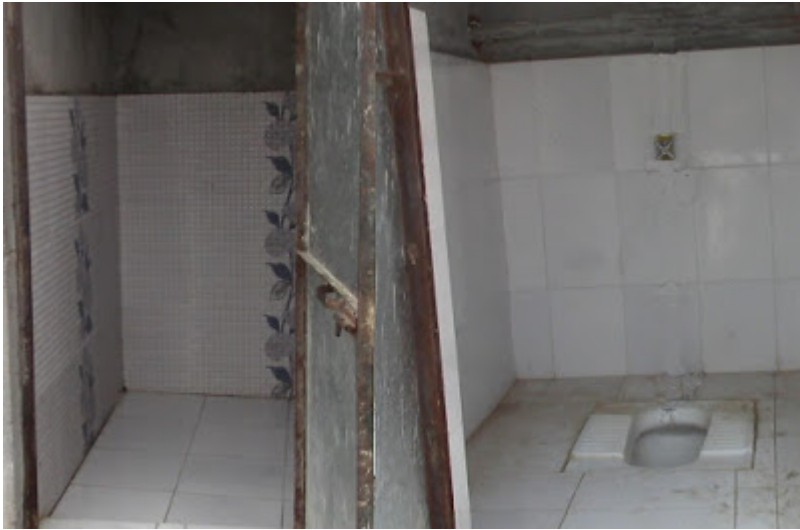
The quality of construction of the toilets and bathrooms was fairly good with brick and cement mortar, vitrified tiles, UPVC pipes and brass and ceramic fittings as shown in the picture below.

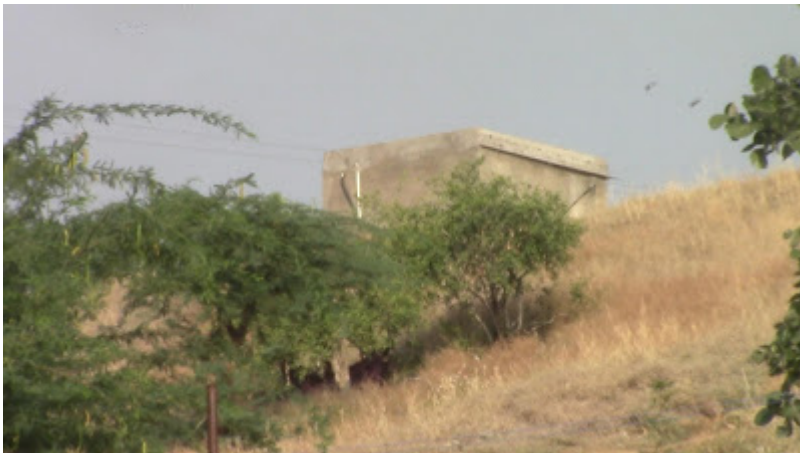
The campus has a hand pump in which there is inserted a two phase submersible pump of one horsepower (HP). Initially after the toilets and bathrooms were constructed they were fitted with two numbers of one thousand litre tanks in addition to the one thousand litre tank that was already there for the three toilets built earlier. These tanks were connected to the submersible pump. However, this total of three thousand litres of water supply proved totally inadequate for servicing fifteen bathrooms and eighteen toilets. The tanks would empty out within a few minutes during the morning hours of heavy use and then filling them up again and again was a big problem. Later during the day the tanks would remain empty and so the children would have to cart water in buckets from the handpump to the toilets over a distance of over a hundred metres which is a labourious exercise. Given this water shortage the toilets began to stink badly and became a potential health hazard. Moreover, the three septic tanks for treating the sewage were also improperly designed and the outflow from them was collecting near the tanks and creating a stinking pool of dirty water that was contaminating both surface and ground water. One of the septic tanks had even cracked due to improper design and construction that left one of the brick walls of the tank exposed without a retaining support, as a result of an inadequate understanding of the topography and soil quality of the area on the part of the mason who constructed it, adding to the problems.

To rectify the situation it was decided to build a ten thousand litre concrete tank on top of the highest hillock in the campus so as to provide enough water storage for the present and future needs of the school at all points as shown in the picture below.

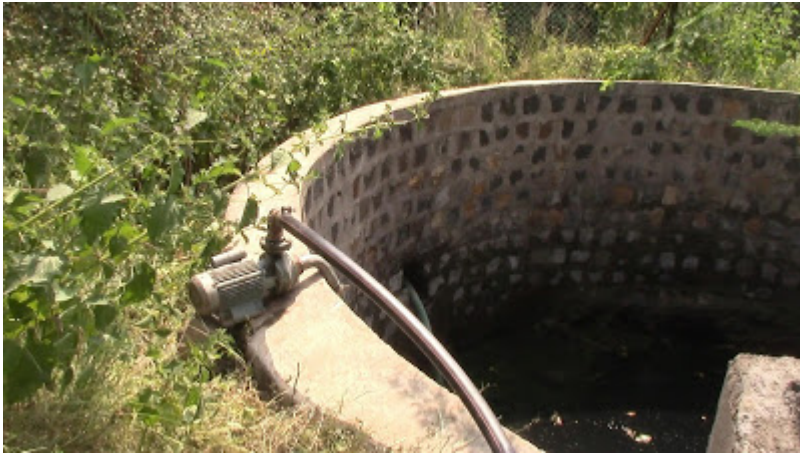
Given the uncertainty of electric supply we installed a 5 HP diesel generator and this improved the delivery of water by the pump but this was an expensive option that could be adopted only in emergencies when there was no electricity supply at all due to load shedding and not regularly. To solve this problem it was decided to lift water from an open well shown below that was there in the campus which was being used only for irrigating the two vegetable farms in the campus. The submersible pump in the hand pump was to be used henceforth only for drinking water purposes.

The problem was that this open well too had a 1 HP pump on it and unlike submersible pumps these pumps have less power and so it could not push water up to the hill top tank located at a distance of 250 metres and height of 25 metres from the well. First we replaced this pump with a 2 HP pump from Kirloskar Brothers but that too did not work. We then chose a 2 HP pump from another company and that also failed to work. Finally, a third pump from yet another company was able to lift water up to the hilltop tank, thus solving the problem temporarily. There was a small hiccup as the weight of all the water in the pipeline proved too much for the plastic foot valve that we had put at the end of the suction pipe and it went kaput!! We then replaced it with a more robust foot valve. Currently the water level in the well is very high and just 2 metres below ground level. But as summer approaches and the water level goes down it is likely that the pump will not be able to lift water to the hill top tank. Therefore, in future we will have to make a further investment in replacing the 1 HP submersible pump in the hand pump with a 2 HP one.

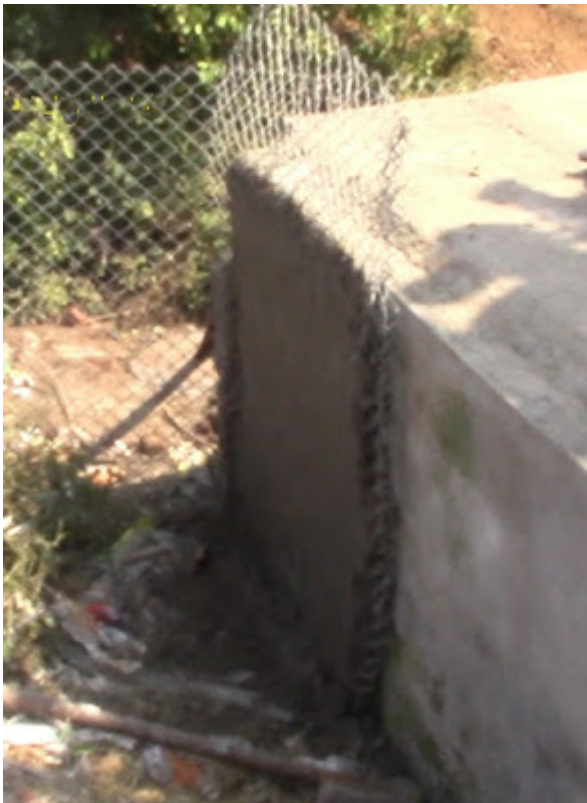
The bigger problem was regarding the disposal and reuse of waste water. Huge amounts of waste water were being generated from the bathrooms and toilets and these were being released untreated into the surface and ground near the septic tanks and were polluting the water sources of the school and also other farmers nearby in the village. First the cracked septic tank was repaired with reinforcement and supported by a retaining wall to ensure that it did not crack again as shown below.

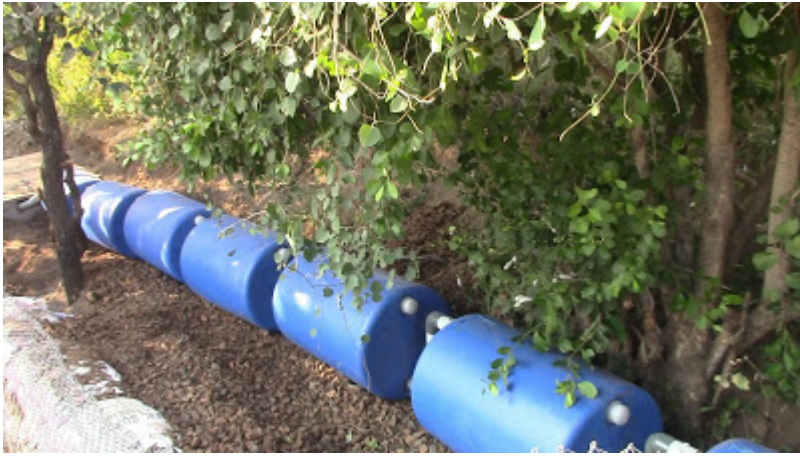
Then a water treatment system was put in place to clean the water flowing out of the septic tanks. This consisted of plastic 200 litre drums laid horizontally filled successively with brick crush, sand and charcoal as shown below. Though the use of these three purifiers is well established, it is the first time in India that they have been put into a horizontal drum assembly to reduce the costs involved in water treatment. Since space is not a constraint, this is a very cheap and effective system.

The water from the septic tanks enters this system of tanks and gets purified while passing through them to reach a Biological Oxygen Demand level less than the 30 mg/litre value for release into the soil prescribed by the Central Public Health and Environmental Health Organisation. However, instead of releasing this water into the soil it is being collected in a tank and recycled to flush the toilets thus saving considerably on the use of potable water for this purpose as shown below. The waste water consequently flows in a closed loop repeatedly after being treated. The excess treated waste water is used for gardening and plantation purposes. There is a vigorous soil and water conservation and plantation exercise going on in the school to improve both water and biomass availability so as to eventually make the campus energy sufficient also.
